# VAPOR LOCK CAUSE AND CURE

The following information has been compiled from extensive research and testing performed by Chevrolet Engineering and RV manufacturers concerning fuel handling problems of the Class A Motor Home (during 1982 and 1983). Chevrolet and the RV manufacturers examined typical "problem units" furnished by various owners in order to better understand "real-world" vapor lock problems in the highly customized Class A Motor Home and develop corrective actions.

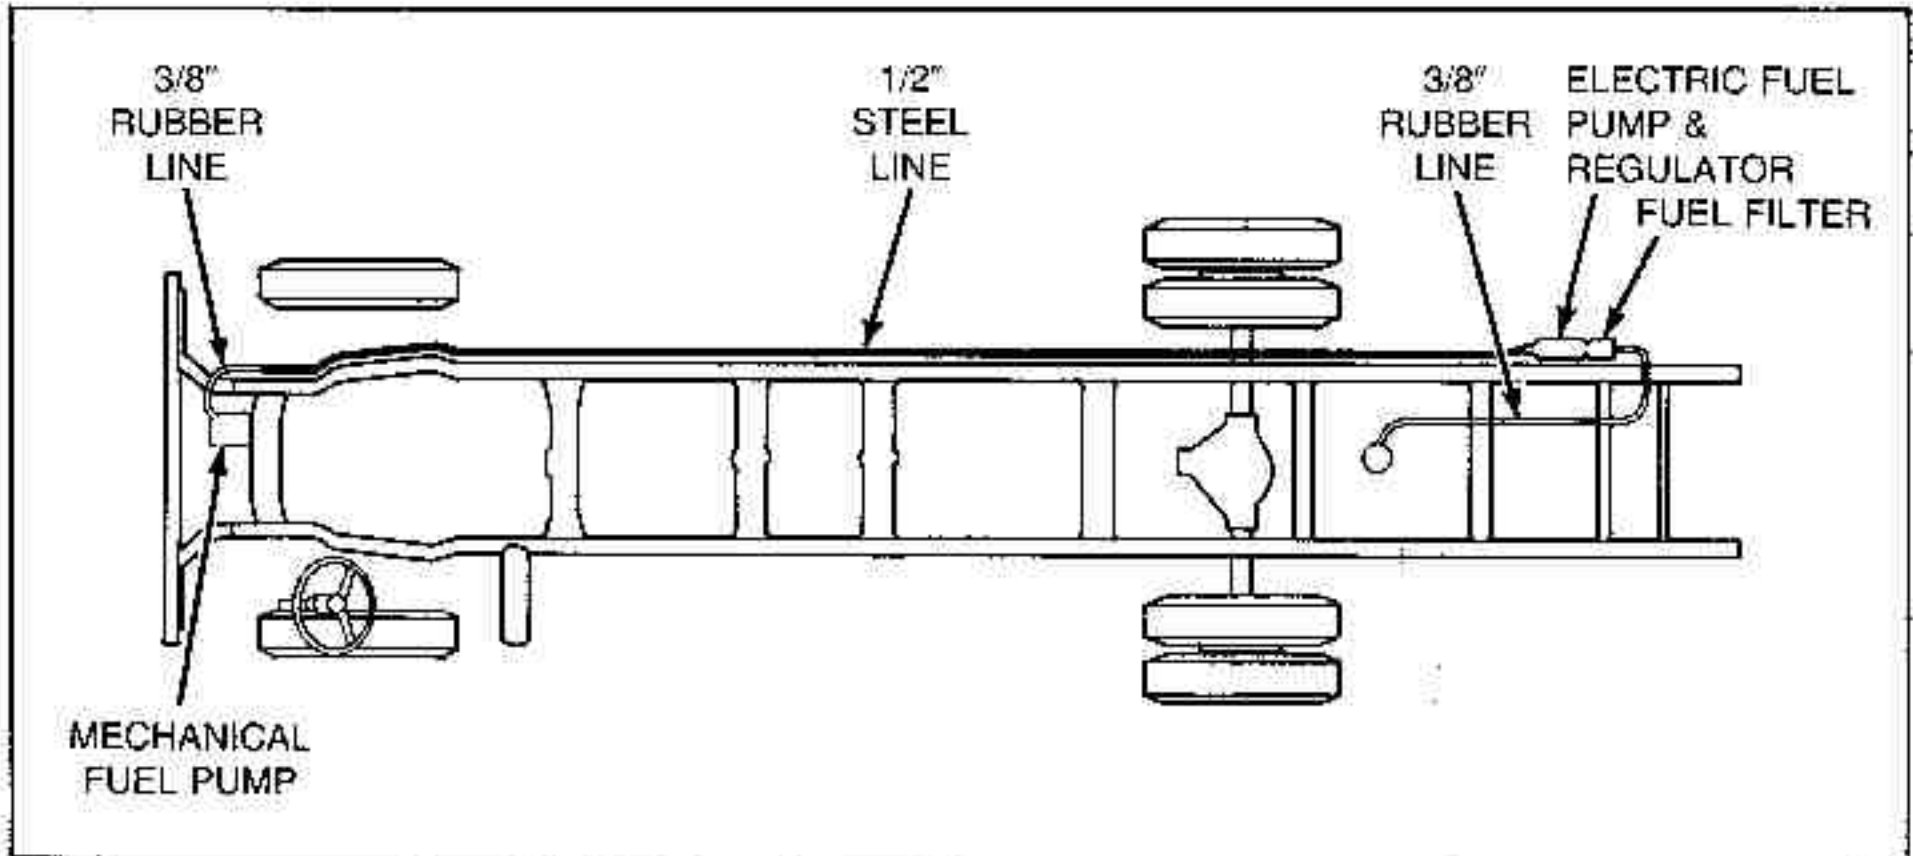
Figure A7-7-2 — 1984 Recommended Field Fix

Chevrolet and the RV manufacturers' representatives determined that 100 percent of the motor homes produced with plumbing errors such as those above could have vapor locking problems. Investigation showed that a properly plumbed fuel system down the inside of the frame rail was also not a 100 percent cure for the problem.

- A one-half inch steel fuel line mounted on the outside of the frame rail, protected against rub and chafe (see Figure A7-7-2).

- An electric fuel pump mounted off the frame at the tank using an adjustable regulator set to 5 PSI at engine idle measured at the mechanical pump inlet (see Figure A7-7-2). Best success was obtained with the Holley Fuel Pump (No. 12-802) that includes a regulator and has ample volume for this engine (see Figure A7-7-3).

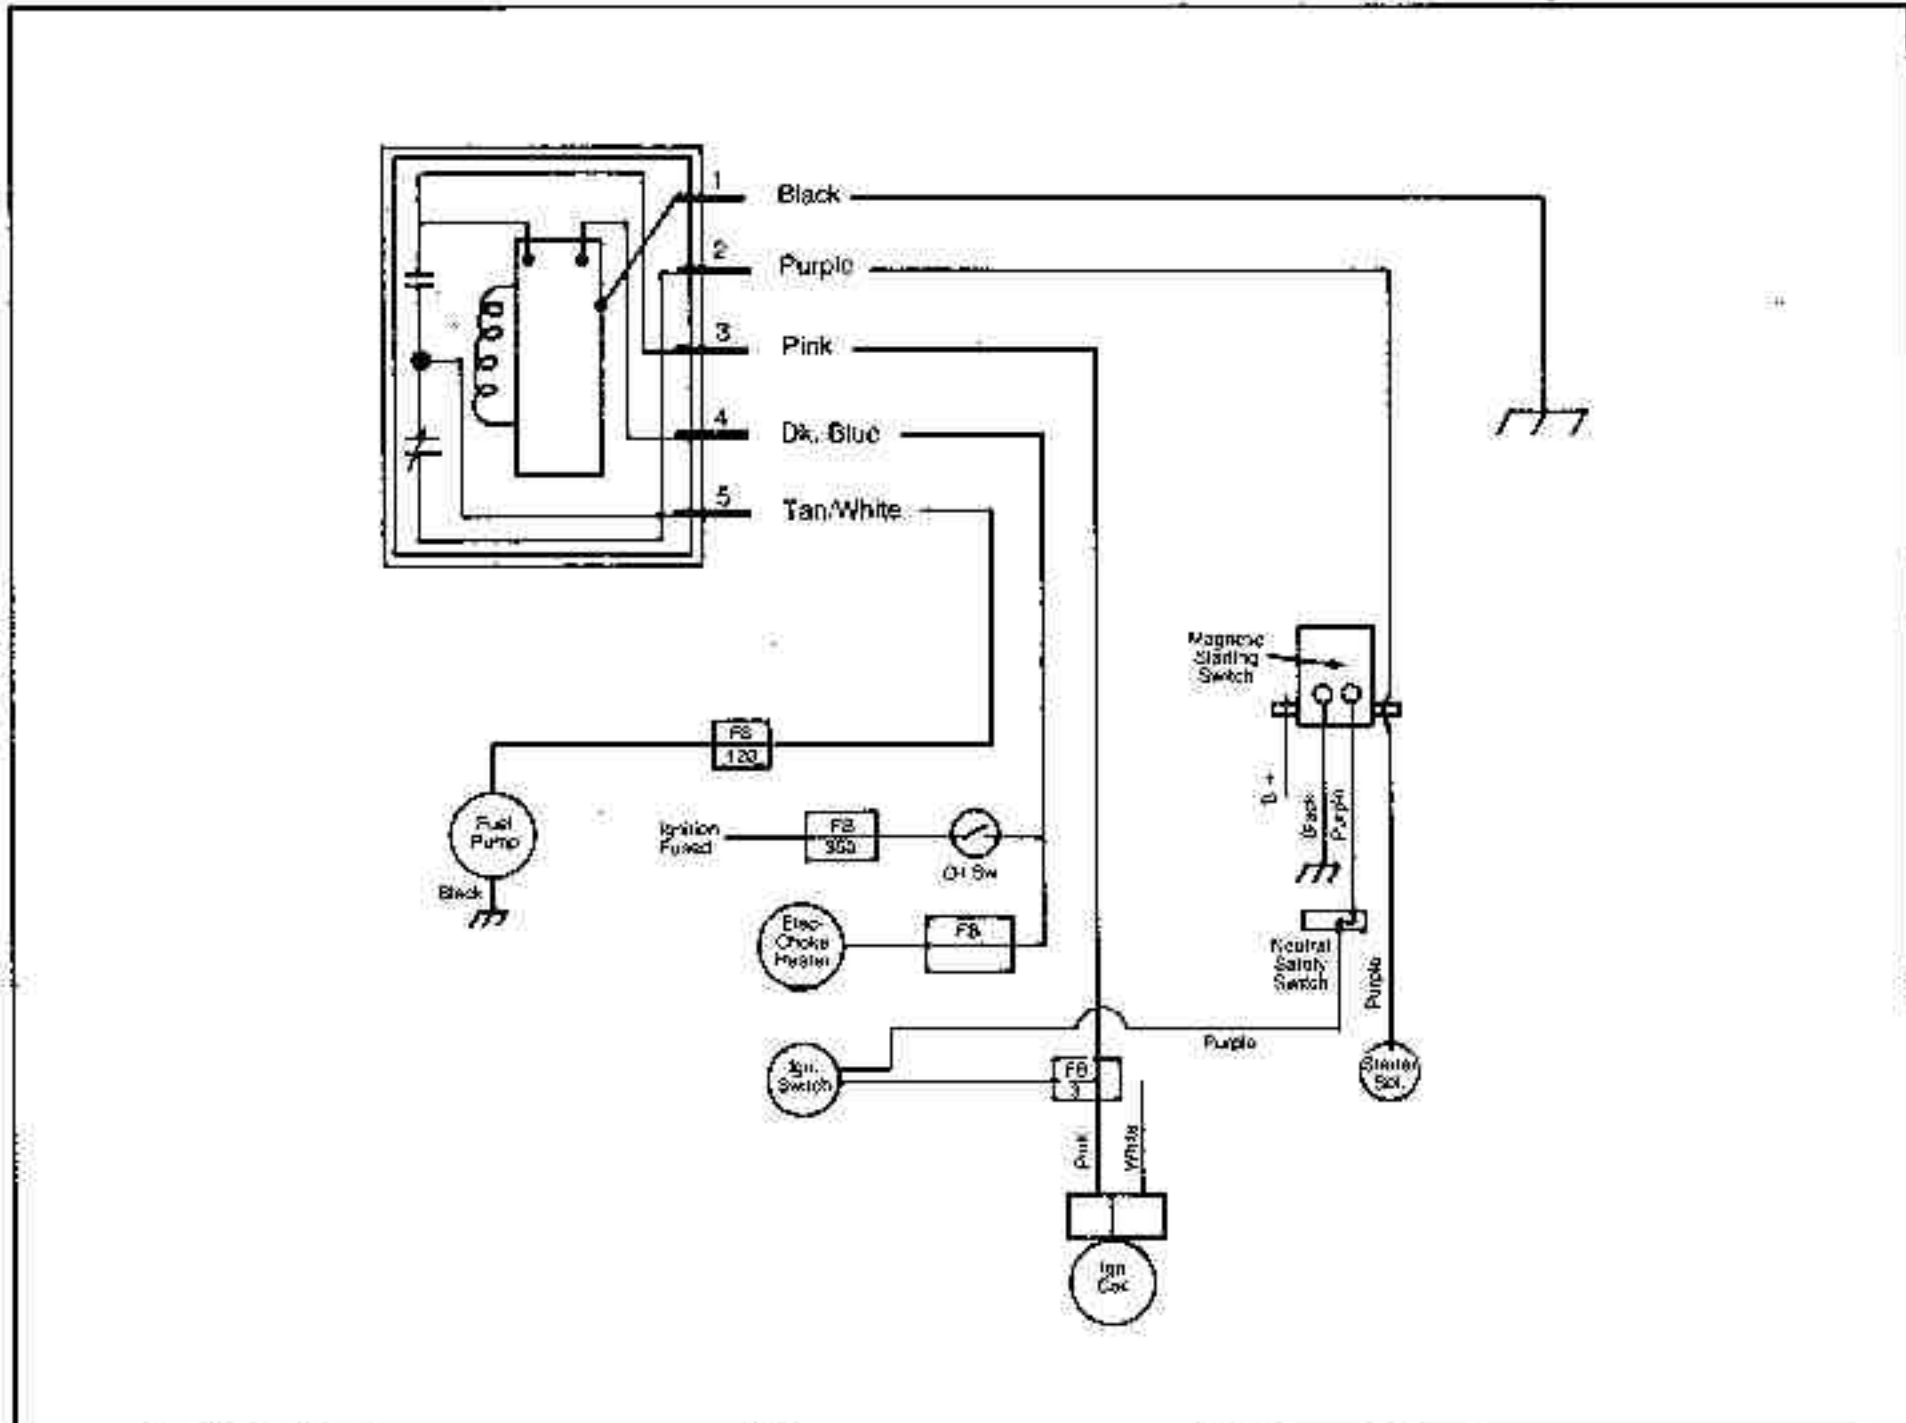
Figure A7-7-6 — Engine Electrical Fuel Pump Relay — Typical Wiring Diagram

**NOTE:** Without activation of the electric in-tank fuel pump, the chances for a vapor lock in the system increases because of the increased workload on the mechanical pump through the electric pump. To check the system, perform the following operational test. Turn the ignition key to the RUN position. Have an assistant check (listen/feel) the tank end for pump operation as a capacitor charges in the relay. The pump will run for approximately five seconds after the key has been turned. (Twelve volts is also supplied to the pump in the crank position and as the engine starts and oil pressure builds, 12 volts is supplied to the electric fuel pump whenever the engine is running.)
